Landslides

Profiling Hazard Event

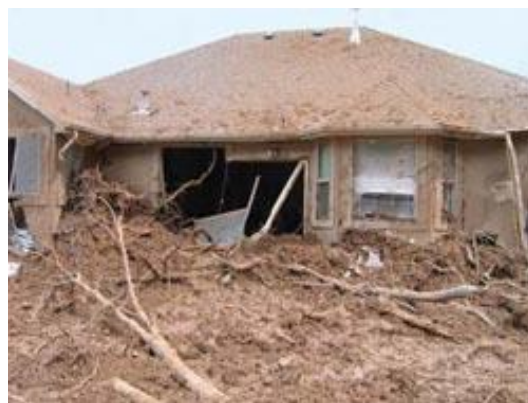
The rapidly moving landslide that slammed into this house at 7687 South 1650 East, South Weber, broke through the back wall and injured a child inside.

Around 9:30 p.m. on Sunday, April 9, 2006, a rapidly moving landslide in South Weber broke through the back wall of a house at 7687 South 1650 East, injuring a child inside. The landslide started on a steep slope near a pond in a gravel pit atop a bluff behind the house. Subsequent investigation found evidence of subsurface water flow from the pond to the slope.

Water seepage and saturation of materials atop the bluff likely triggered the landslide, but the steep slope, the weight of fill placed on the top of the slope, and weak underlying geologic materials were contributing factors. Also, a major rain and snow storm on April 4 -6 dropped approximately 2 inches of water, likely causing surface and subsurface water levels to rise. After the landslide, the pond was drained to reduce further sliding. The 1650 East landslide and a similar one nearby that demolished a barn and blocked South Weber Drive (State Route 60) in 2005, demonstrate the destructive nature of rapidly moving landslides and the risk of building at the base of steep slopes.

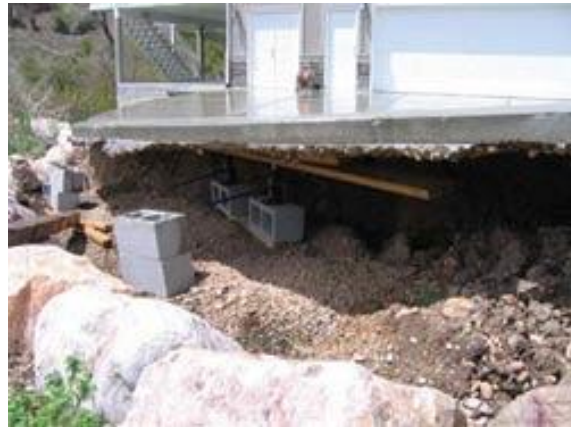
Landslide movement left this concrete driveway slab suspended in the air in the Creekside Drive area, Mountain Green.

Continued movement of the largest of the five landslides forced the evacuation of a severely damaged house at the top of the slide, and damaged two others.

Despite favorable subdivision-wide and lot-specific geotechnical studies, landsliding occurred within only a few years of development on the pre-existing landslide deposits. Stabilization of the landslides, particularly the largest one, will likely prove costly and technically challenging.

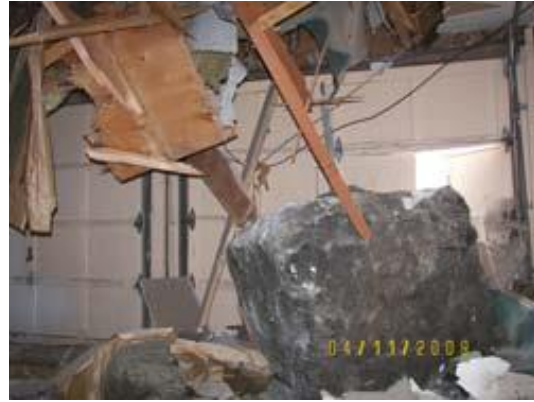
Boulder that damaged the vacant house at 1496 North 1550 East, Provo. Boulder is estimated to be 4x5x4 feet. Photo courtesy of the Provo Fire Department.

At 1496 North 1550 East, a boulder bounced over the back fence and into the back of the house. Inside the house, the boulder damaged the ceiling and crashed through a wall, before falling through the floor and into the garage door.

The source for the rock fall in both 2005 and 2009 is a cliff band in the Mississippian Deseret Limestone on “Y” Mountain, about 2,600 vertical feet above the houses. Numerous large rocks from prehistoric and historical rock-fall events are scattered throughout the neighborhood and on the hillside above, indicating that these lots are in a high rock-fall hazard area. Although the occurrence of this rock fall does not necessarily indicate a heightened rock-fall hazard under present conditions, rock falls are possible in this area at any time and typically occur with no warning, often during and following storms, periods of snowmelt, and earthquakes.

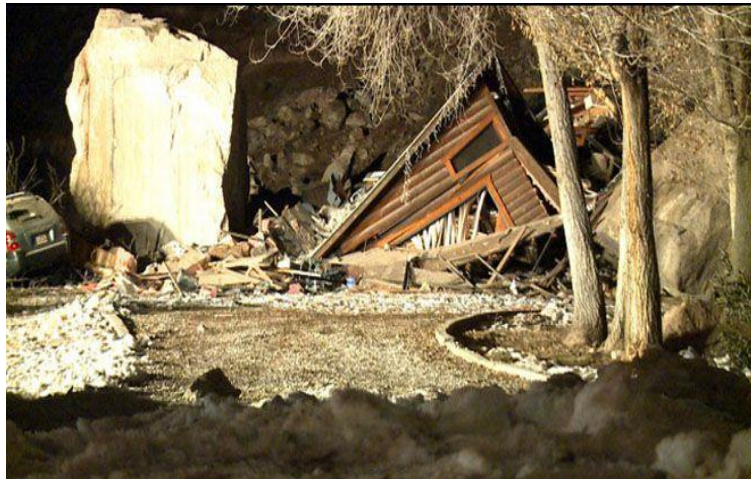
Source: ksl.com

Another rock fall occurred in Rockville on December 12, 2013. A massive boulder the size of a tractor came loose at the top of a cliff near Zions National Park and tumbled down the mountain, crushing a home and killing two people inside. The Utah Geological Survey contributes a week of severe weather, a lot of freeze-thaw, and a lot of moisture to the movement of the boulders.
